Play Area Equipment Report 2022

10th November 2022

South Avenue Recreation Grounds

Reeds Lane Recreation Grounds

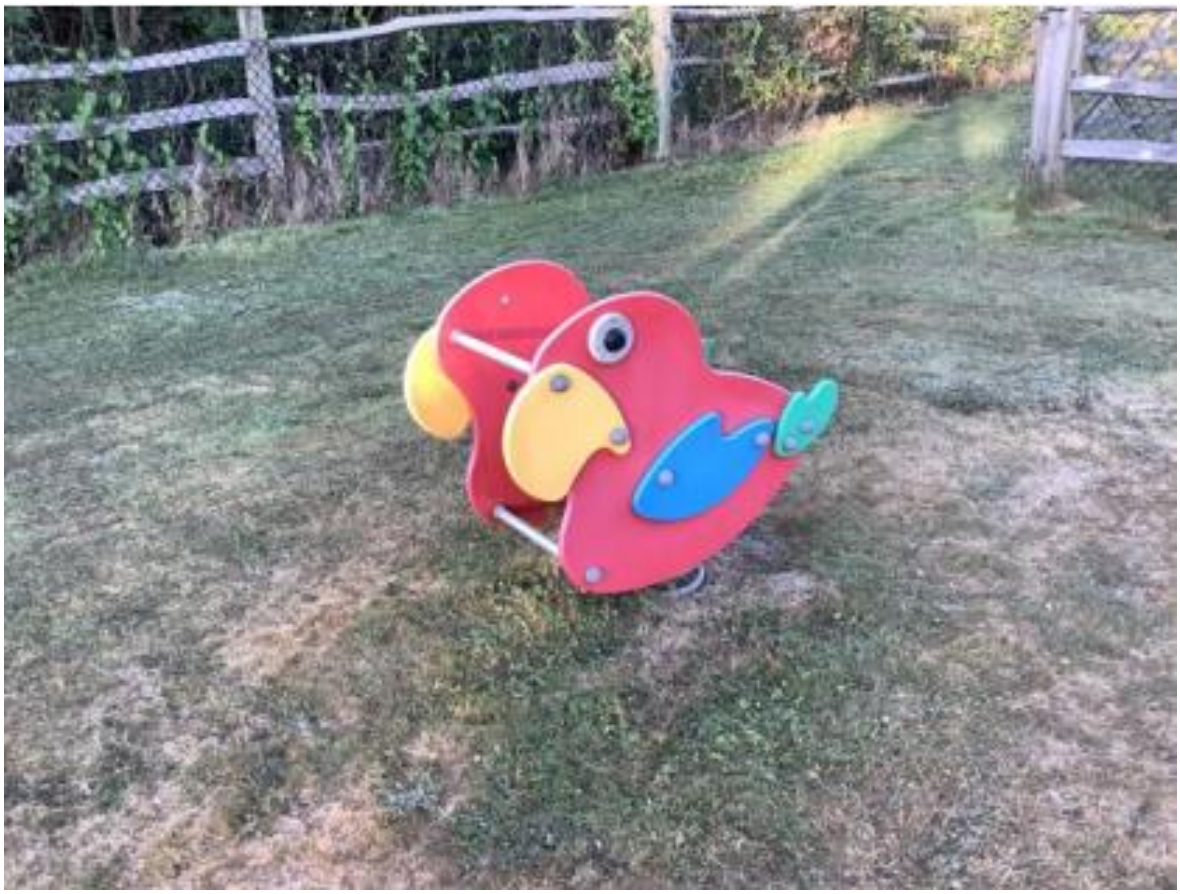
Rocker – Bird

Low Risk

- No Repairs/Actions required.
